CONDITION|TREATMENT REPORT

Title: Five Flags Mural

Artist: Renee Faure

Owner: Senate, State of Florida

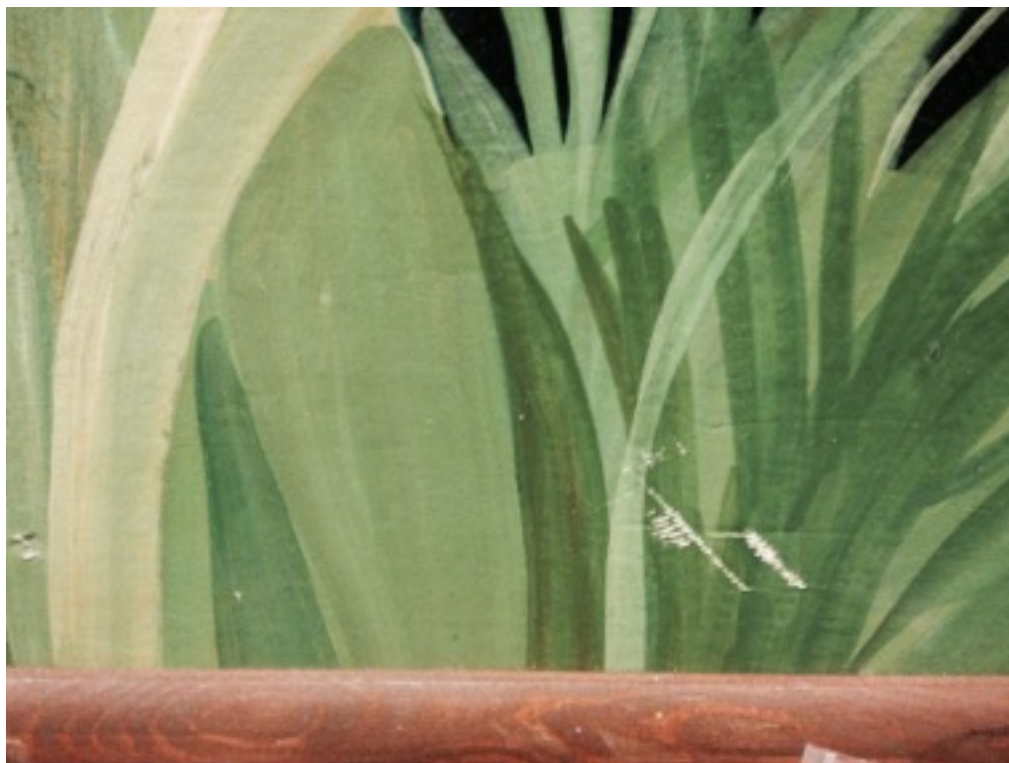
Damage to the painting includes scrapes and gouges especially along the bottom of the work. Accretions and an accumulation of surface grime is also noted. The figure laid over the female figure on the proper left has begun to come away from the painted figure beneath. There are other smaller areas of de-lamination especially where there are joins in the pieced support layer. Where de-lamination has occurred the paper support is splaying and some loss has occurred.

Damage or Loss: There are local scrapes, scratches and areas of loss where the support shows splaying

Detail: Scrapes and gouges

3. The first step in treatment will be surface cleaning the design layer with low density sponges to remove accretions and surface grime.
4. Areas of scratches and gouges will be consolidated with BEVA D-8 and Lascaux 498 20x..

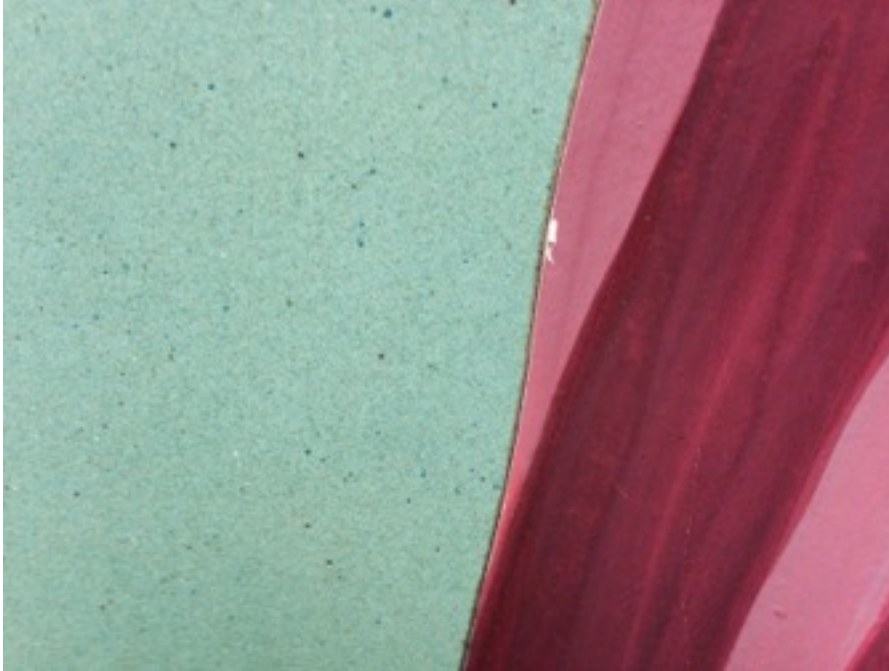
Delamination of pieced support, splaying of support
Detail: Airbrushed area

Brush painted area

5. Stabilization of the peeling overpainted figure will be carried out with facing after testing facing adhesives on the perimeter of the paint layer.
6. Areas where the ply support has splayed will be consolidated.

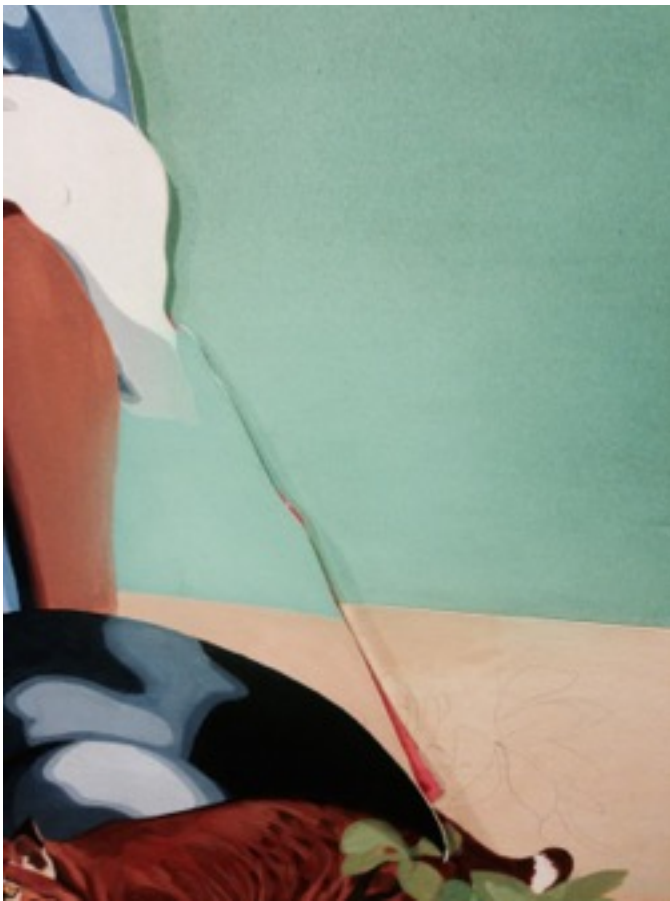
The painting is carried out in pieces which have then been adhered like a puzzle to a substrate. There are gaps at some of the seams where the substrate is visible. In other areas there is slight lifting where the forms join. There is severe de-lamination of the overlaid female figure mentioned above. The painting support shows damage in some of the scraped and gouged areas.

De-lamination of overlaid female figure on the proper left of the mural
The original pink dress shows beneath.

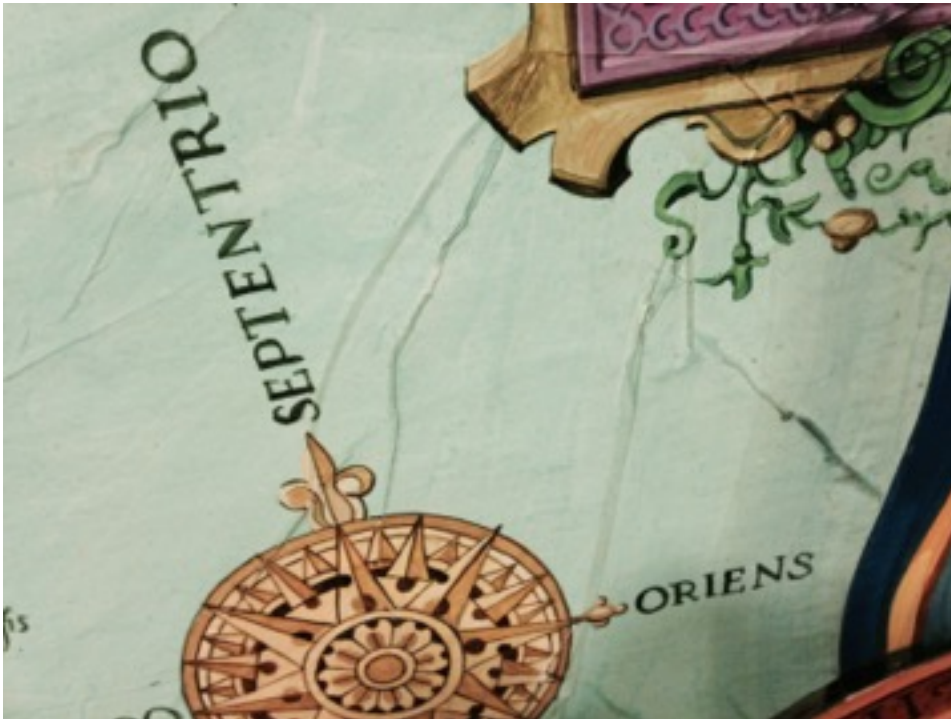
In the area of the map on the lower proper right, the artist has used a more delicate paper support for the paint layer. During the application of this paper to the substrate, the paper has creased. There is abrasion on the high points of the creases. In this area around the edges there is tearing and lifting of the upper paper.

Map area with creased and abraded paper support

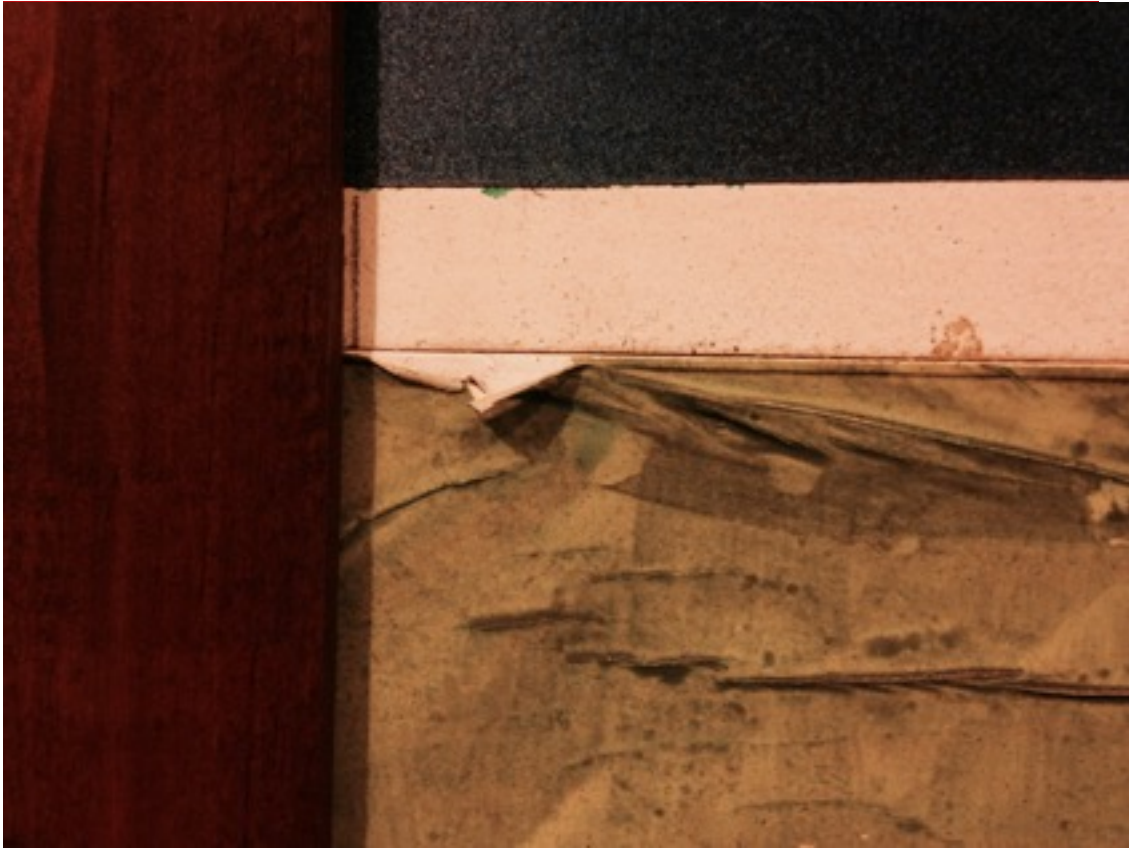
Tear and delimitation of the support in the map area.

De-lamination and splaying of paper support at a join.

Detail: Unpainted underdrawing
