## **Hazardous Working Conditions: Sandels Building, Florida State University**

January 21, 2022

On behalf of the Faculty and staff of the Department of Nutrition & Integrative Physiology with support from the staff of the Dean's Office, and the Faculty from the Department of Human Development and Family Science and the Jim Moran College of Entrepreneurship (former Department of Retail, Merchandising and Product Development).

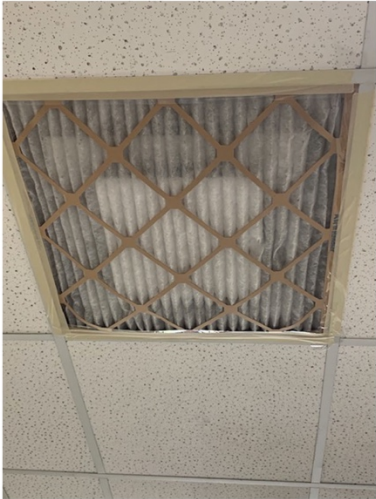
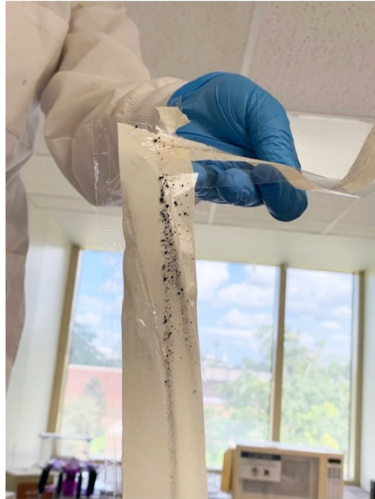
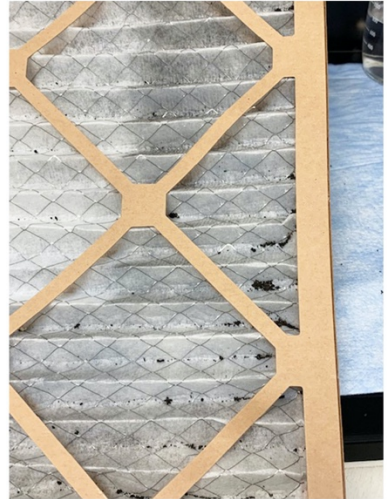
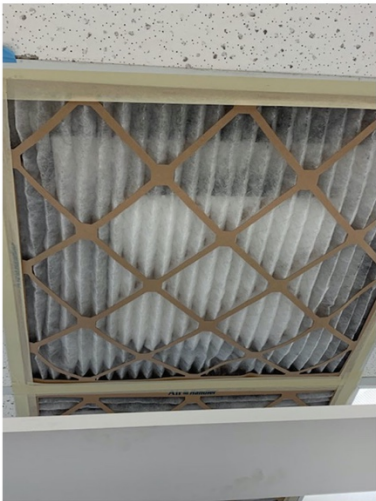
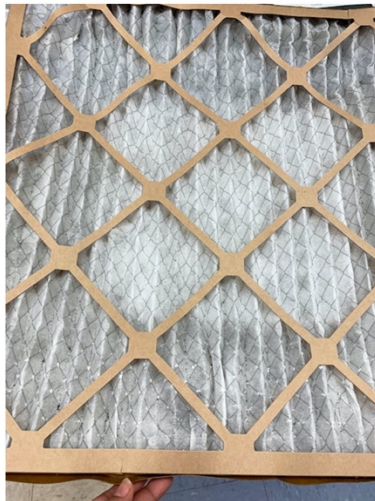
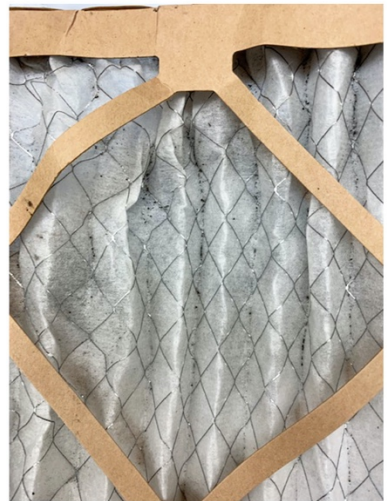
**Figure 3. Air filters taken from Dr. Salazar's lab in rooms 442C and 442D. Pictures were taken on September 6, 2021 before the cleaning of the air ventilation system started in September 7, 2021. Pictures of the filters in rooms 442D and 442C show the blackened filter paper and black particles of diverse sizes.**

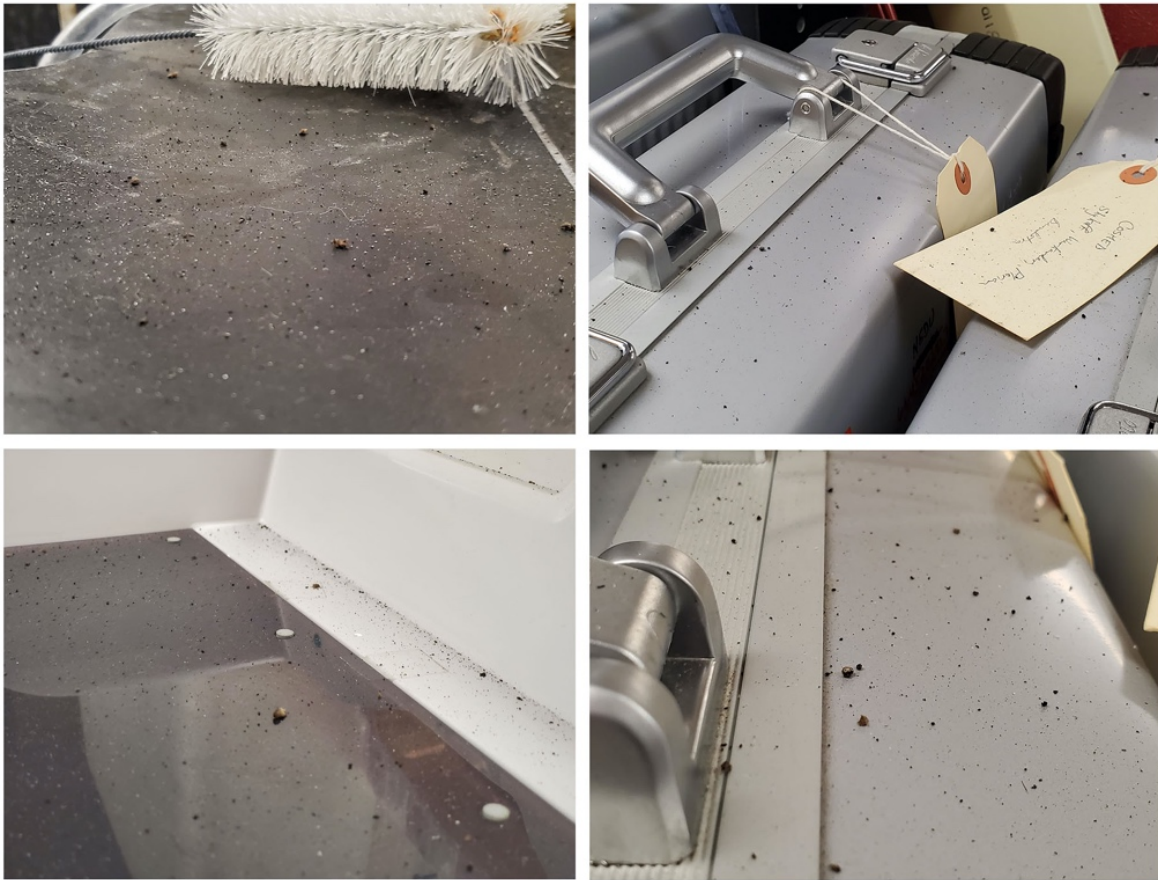
**Figure 4. Example of black particles found on surfaces in the Sandels Building.** Pictures were taken on September 7, 2021 the day when the cleaning of the air ventilation system started. Pictures show the black particles found on top of benches and equipment in Dr. Kim's lab in Room 440.

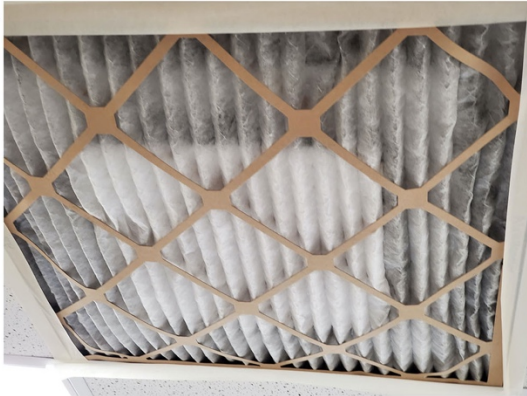
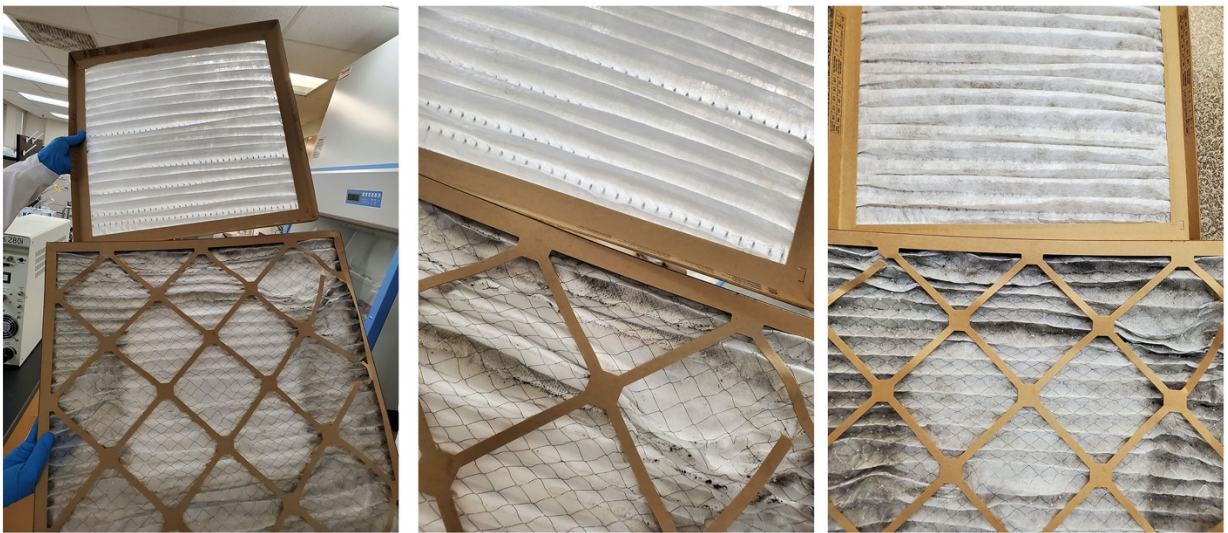
**Filter covering the vent  
in the ceiling of lab**

**Figure 5. Air filters taken from in Dr. Kim's lab in Room 440.** Black particles and blackened paper found on filter covering air vents in Dr. Kim's lab. A) Pictures taken before the filter was removed. B) Pictures comparing the appearance of the filter taken from the lab (bottom) and a new filter (top). The pictures were taken September 7, 2021.

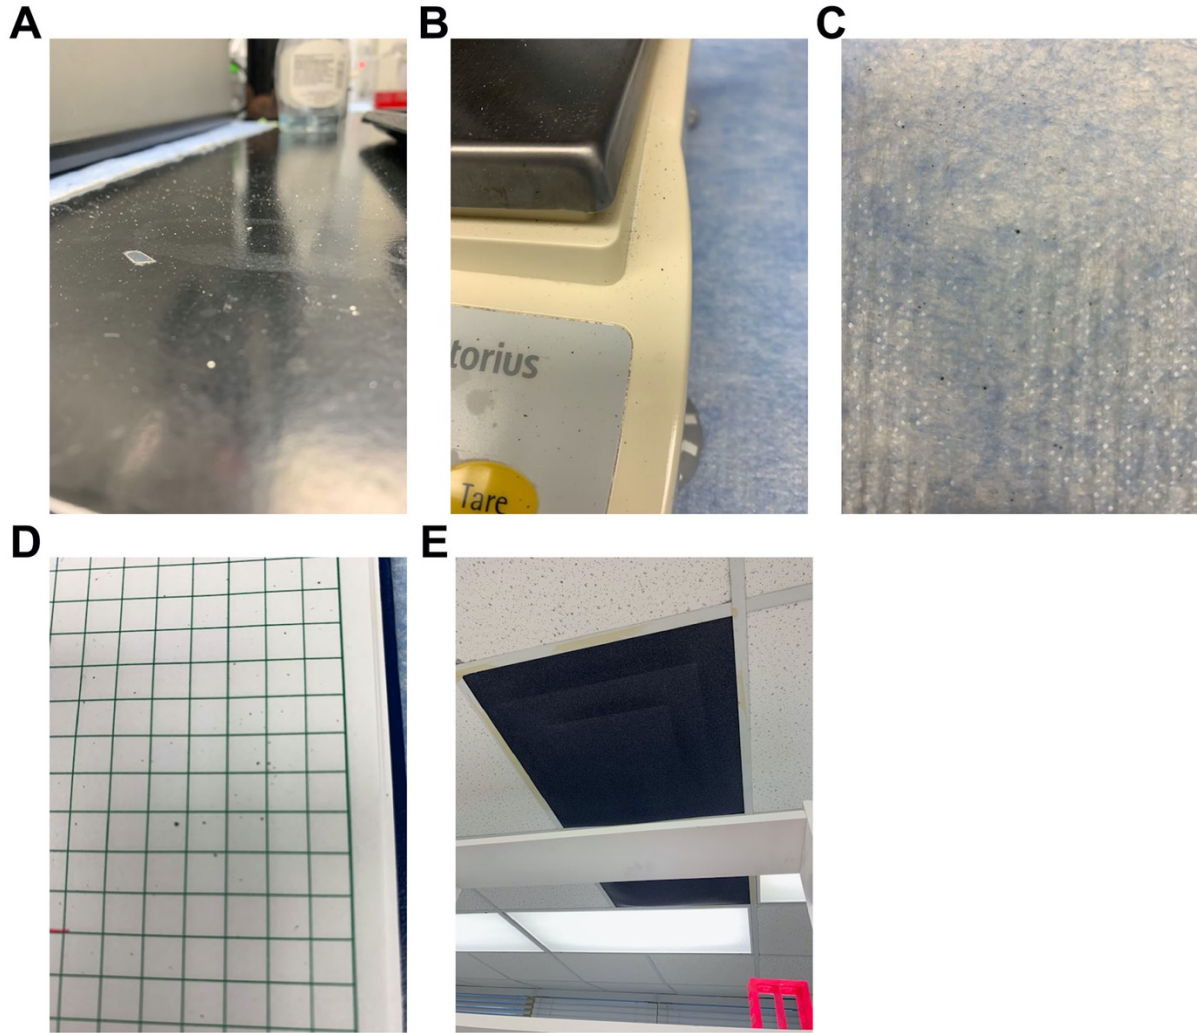
**Figure 6. Dr. Salazar's lab in Room 422D after 4 months of air ventilation cleaning.** Pictures taken January 16, 2022, 4 months after the cleaning began show debris and fine black particles in benches (A), equipment (B), bench pads (C) and in a lab notebook (D) that was left opened overnight. The lab was meticulously cleaned and new bench pads placed a week before the pictures were taken. Particles accumulated even when air vents were covered (E).

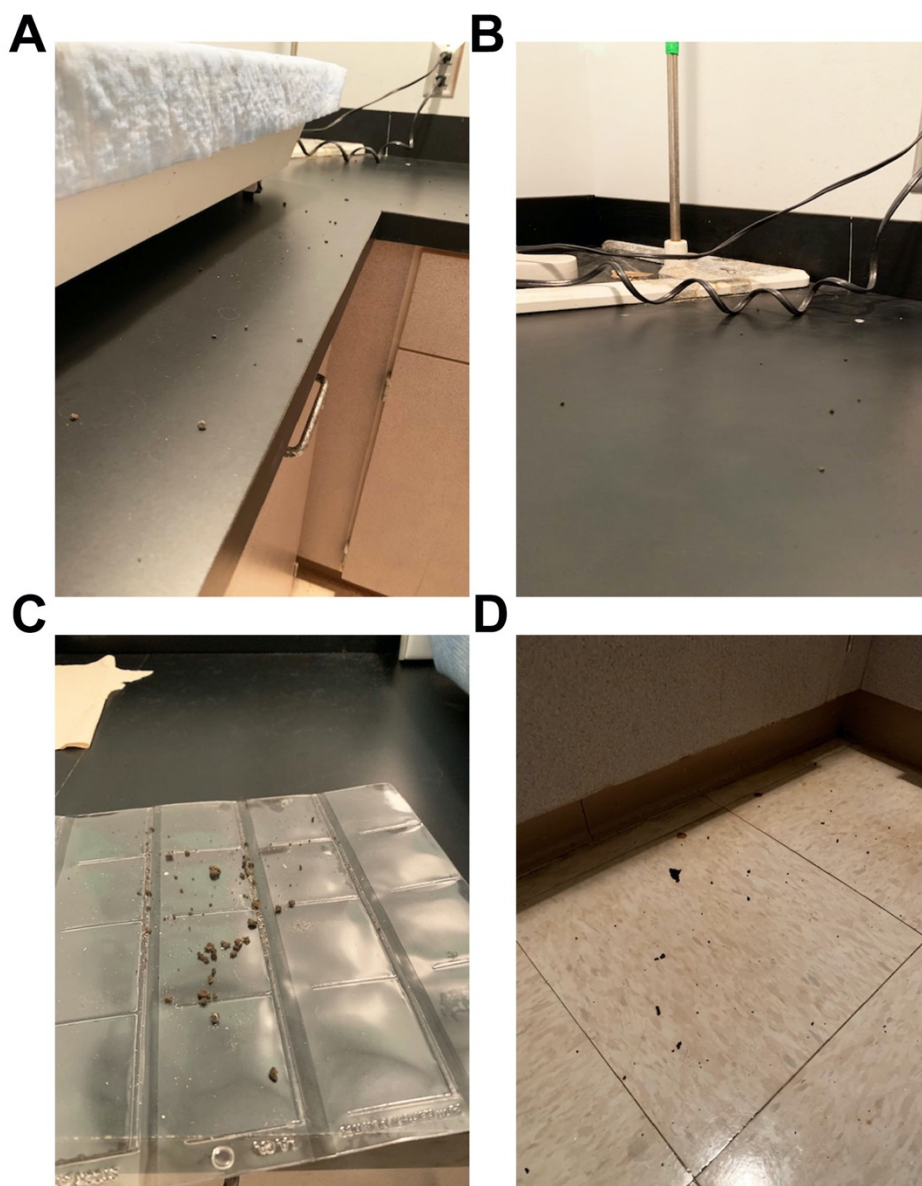
**Figure 7. Dark room 422A after 4 months of cleaning.** Pictures taken January 4, 2022, four months after the cleaning began show big chunks of black debris and fine black particles in benches (A and B). Particles from the benches were collected and are shown in C. Big black chunks also can be seen on the floor.

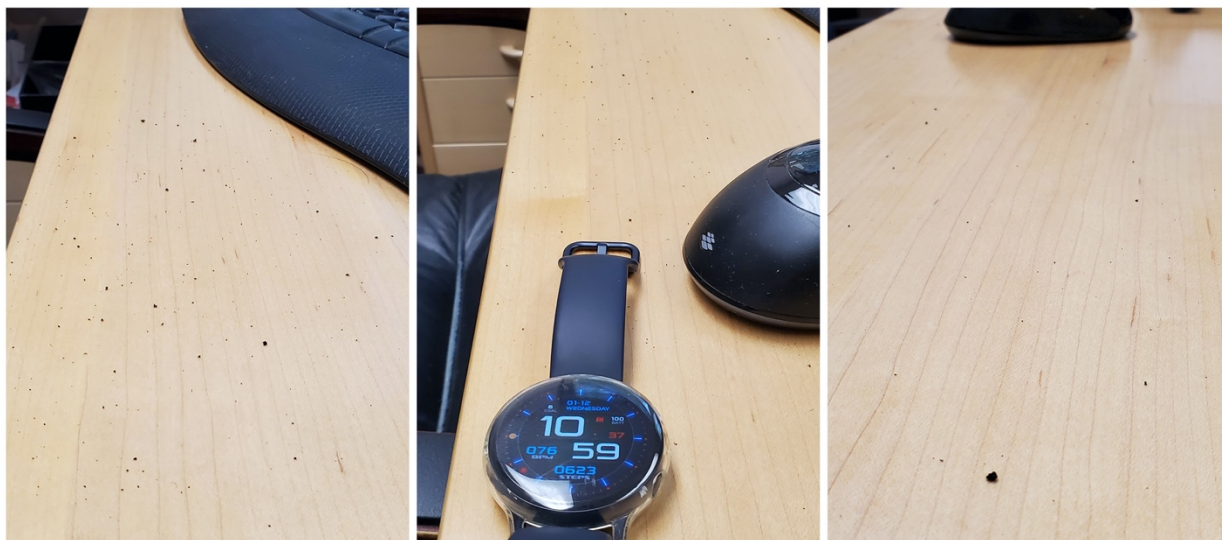
**Figure 8. Dr. Kim's office in room 100B at Sandels building.** Pictures taken January 11, 2022 show black particles of different sizes on top of Dr. Kim's desk.

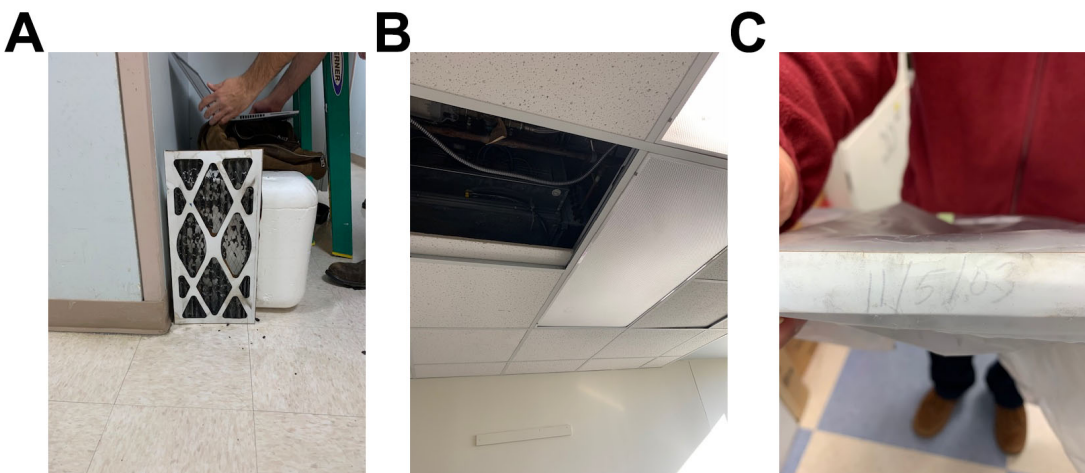
Of concern, on January 18, 2022, facilities removed a filter in Dr. Salazar's lab (room 442C) that had not been changed since 2003 (**Figure 9**). As seen in panel A of the figure, the paper of the filter has completely disintegrated and converted into chunks of black material. Panel C of the figure shows that the filter hasn't been changed in almost 20 years. It is unknown how many other filters in the building are this old or have not been replaced as scheduled (every 3 months). We fear that facilities might not keep records of incidents like this. Dr. Salazar sent the following email to Marian Sumner on January 19, 2022, reporting this finding and the unprofessional behavior from Robert Lewis (facilities supervisor):

*I would like to report an incident related to an interaction with the supervisor of our building Robert Lewis this morning. A filter in my lab in room 442D was replaced yesterday by facilities. According to the facilities personnel, the filter for the coils supplying air to rooms supposed to be changed every 3 months. The filter they removed was from November 5, 2003 and has not being replaced for almost 20 years. I kept the filter.*

**Figure 9. Old filter found in Dr. Salazar's lab room 442C.** Pictures were taken January 18, 2022 and show a filter covered in black material (A) that was removed from the ceiling in room 442C (B). The filter hasn't been changed since November 5, 2003 (C).

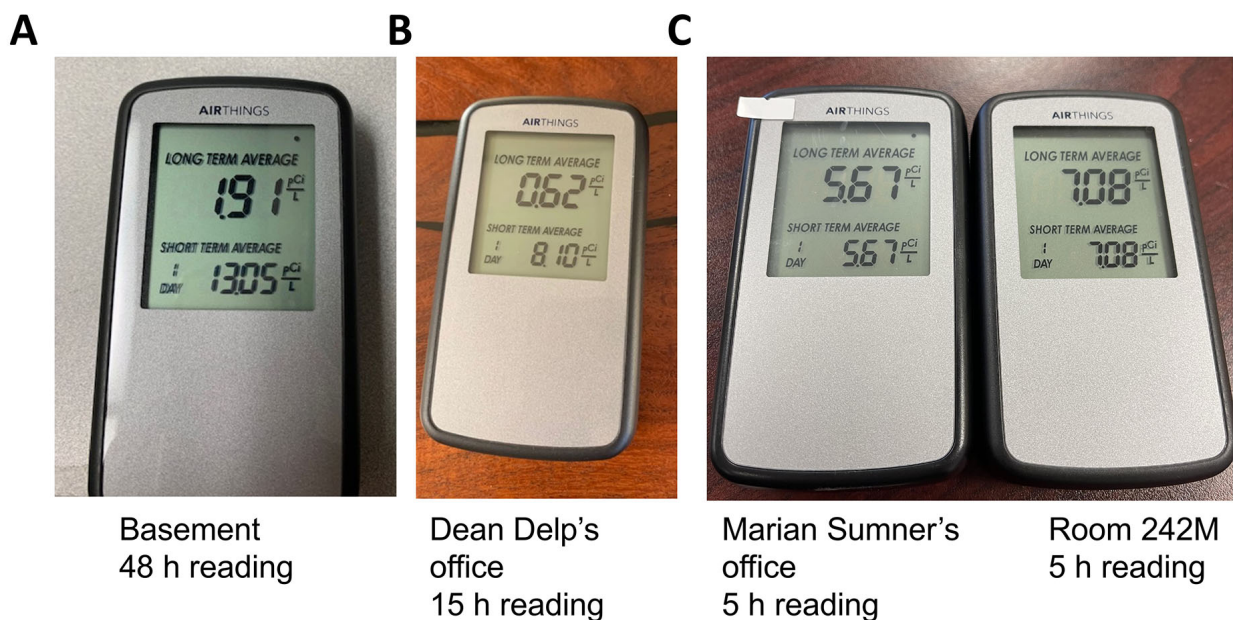
The EPA recommends taking mitigation actions for radon levels between 2 and 4 pCi/L. The levels found at Sandels are extremely high and unsafe. These measurements have to be confirmed by a professional company.

**Figure 10. Elevated radon levels in ground floors in Sandels building.** Pictures of radon meters placed in A) the basement (room B0007A), B) the Dean's office (room 242L), and C) Marian Sumner's office (room 242I) and room 242M. The number in the top reflects the long-term average. Current readings are reflected in the short-term average in the lower part of the screen. In C meters were reset to zero before measurements.

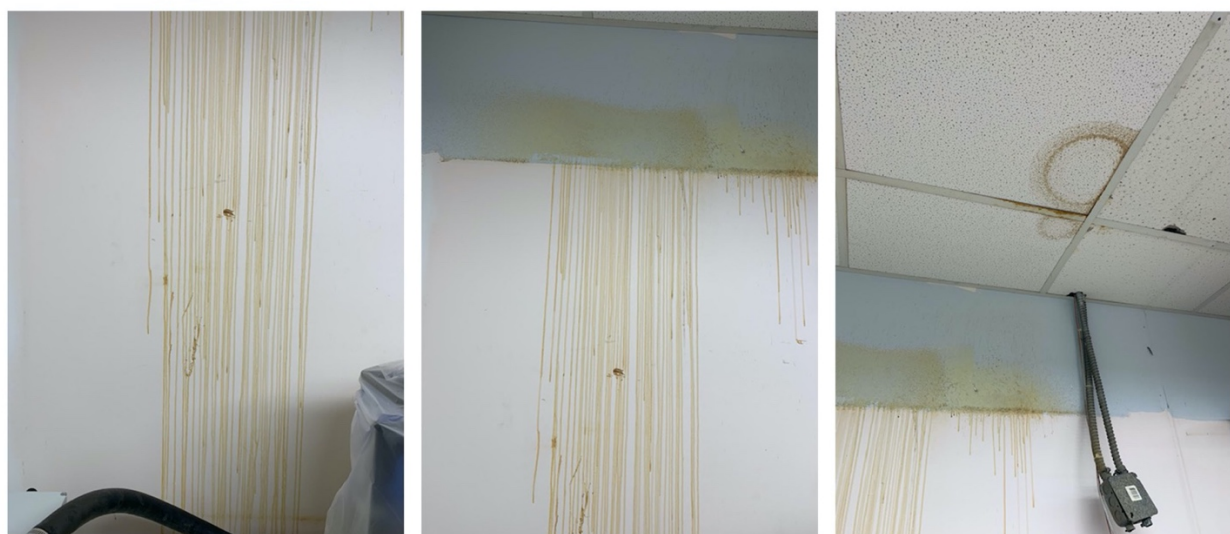
**Figure 11. Room 442E Sandels building.** Pictures show the condition of the wall where the chemical hood in room 442E was placed. Marks of a yellow liquid are a testimony of what was present inside of the hood.

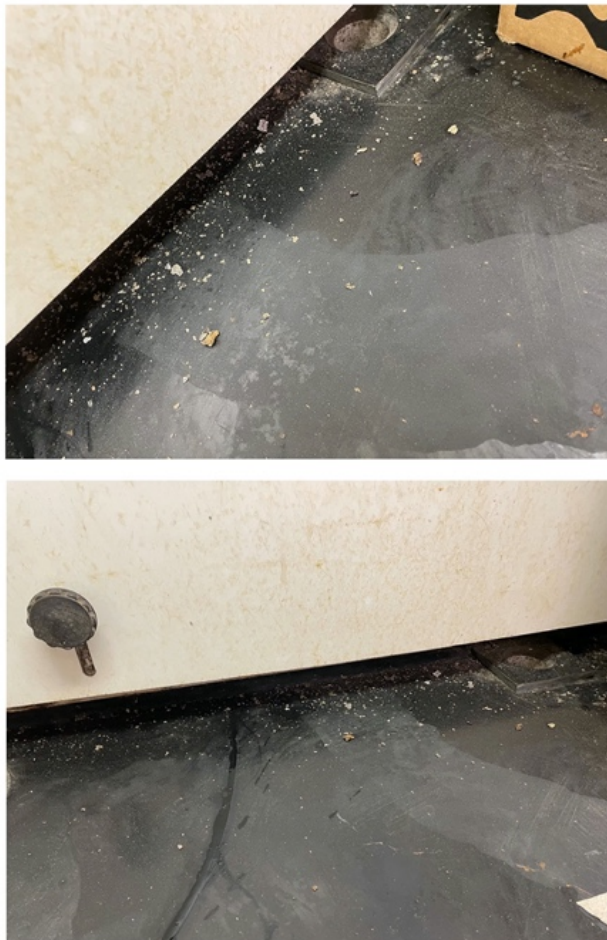
**Figure 12. Chemical hood in Room 442G.** Example of debris found in the chemical hood located in Room 442G, previously occupied by Dr. Sathe and currently assigned to Dr. Cui. Debris is constantly found inside the hood.
