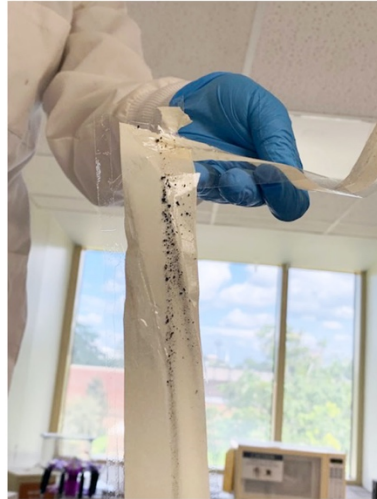
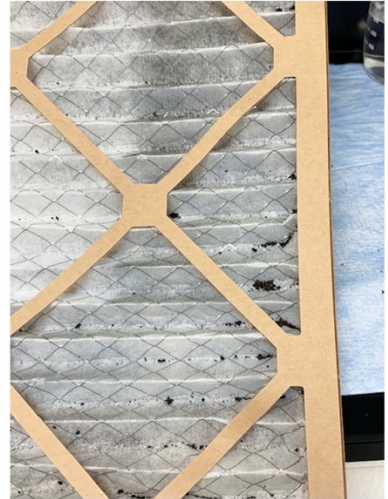
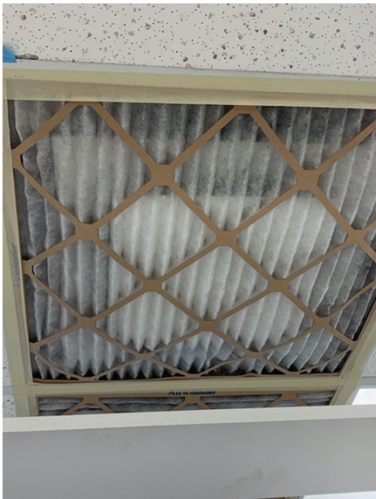
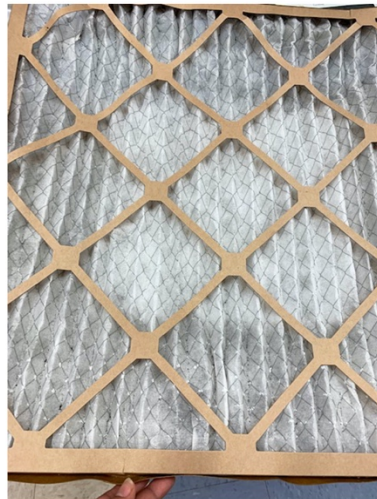
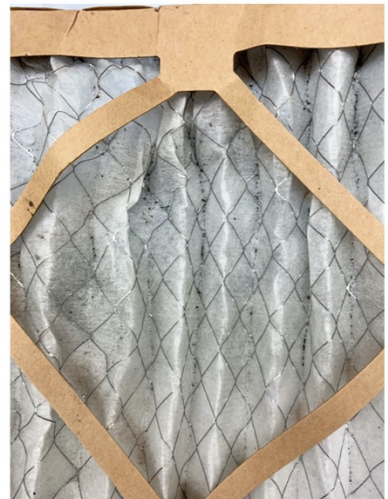
Figure 3. Air filters taken from Dr. Salazar's lab in rooms 442C and 442D. Pictures were taken on September 6, 2021 before the cleaning of the air ventilation system started in September 7, 2021. Pictures of the filters in rooms 442D and 442C show the blackened filter paper and black particles of diverse sizes.

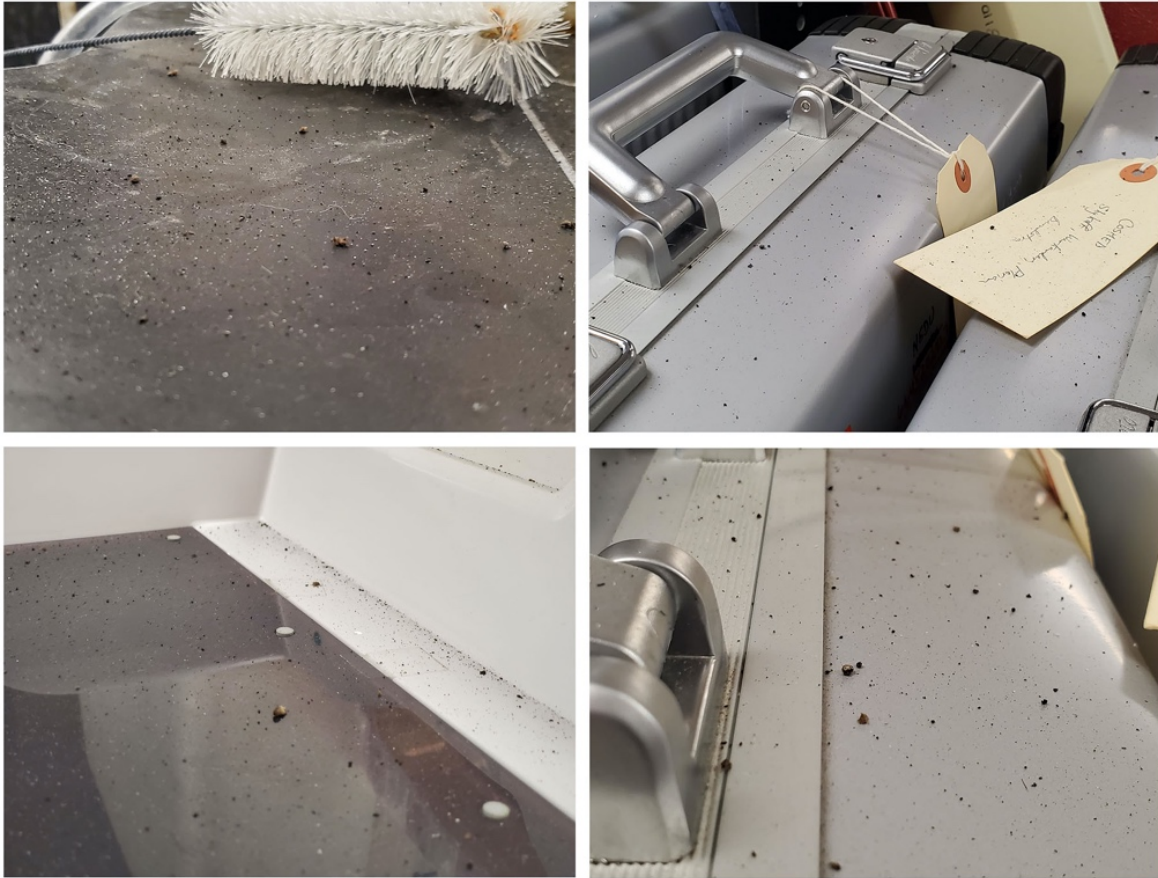
Figure 4. Example of black particles found on surfaces in the Sandels Building. Pictures were taken on September 7, 2021 the day when the cleaning of the air ventilation system started. Pictures show the black particles found on top of benches and equipment in Dr. Kim's lab in Room 440.

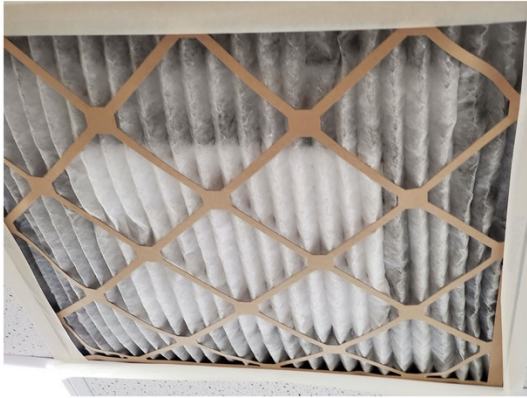
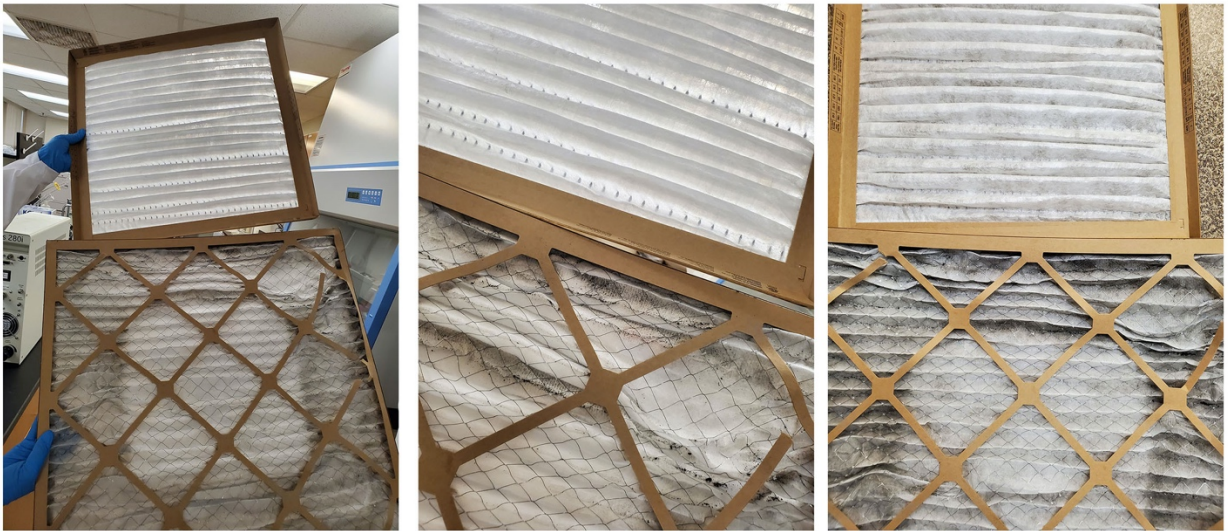
**Filter covering the vent
in the ceiling of lab**

Figure 5. Air filters taken from in Dr. Kim's lab in Room 440. Black particles and blackened paper found on filter covering air vents in Dr. Kim's lab. A) Pictures taken before the filter was removed. B) Pictures comparing the appearance of the filter taken from the lab (bottom) and a new filter (top). The pictures were taken September 7, 2021.

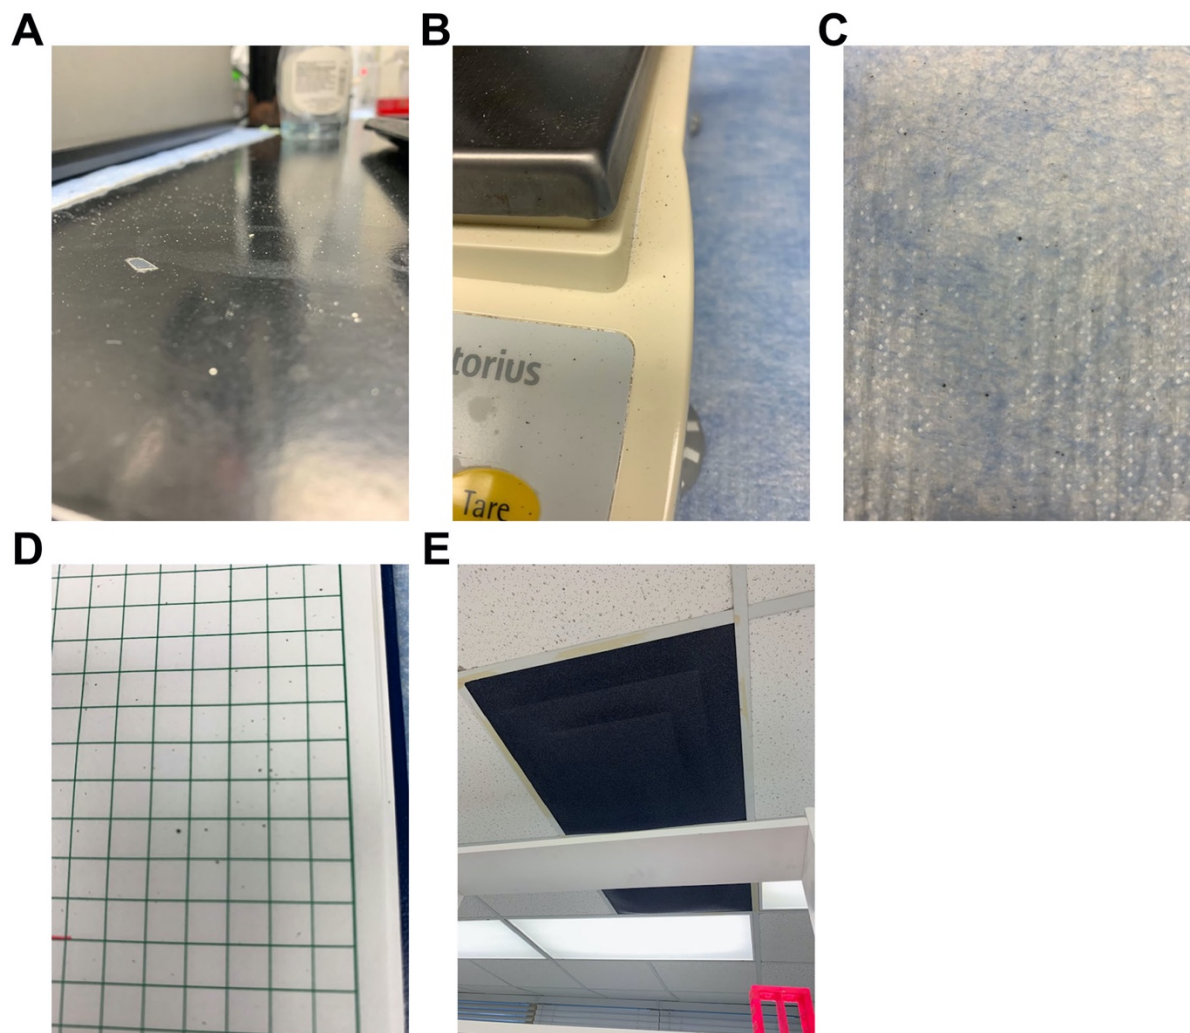
Figure 6. Dr. Salazar's lab in Room 422D after 4 months of air ventilation cleaning. Pictures taken January 16, 2022, 4 months after the cleaning began show debris and fine black particles in benches (A), equipment (B), bench pads (C) and in a lab notebook (D) that was left opened overnight. The lab was meticulously cleaned and new bench pads placed a week before the pictures were taken. Particles accumulated even when air vents were covered (E).

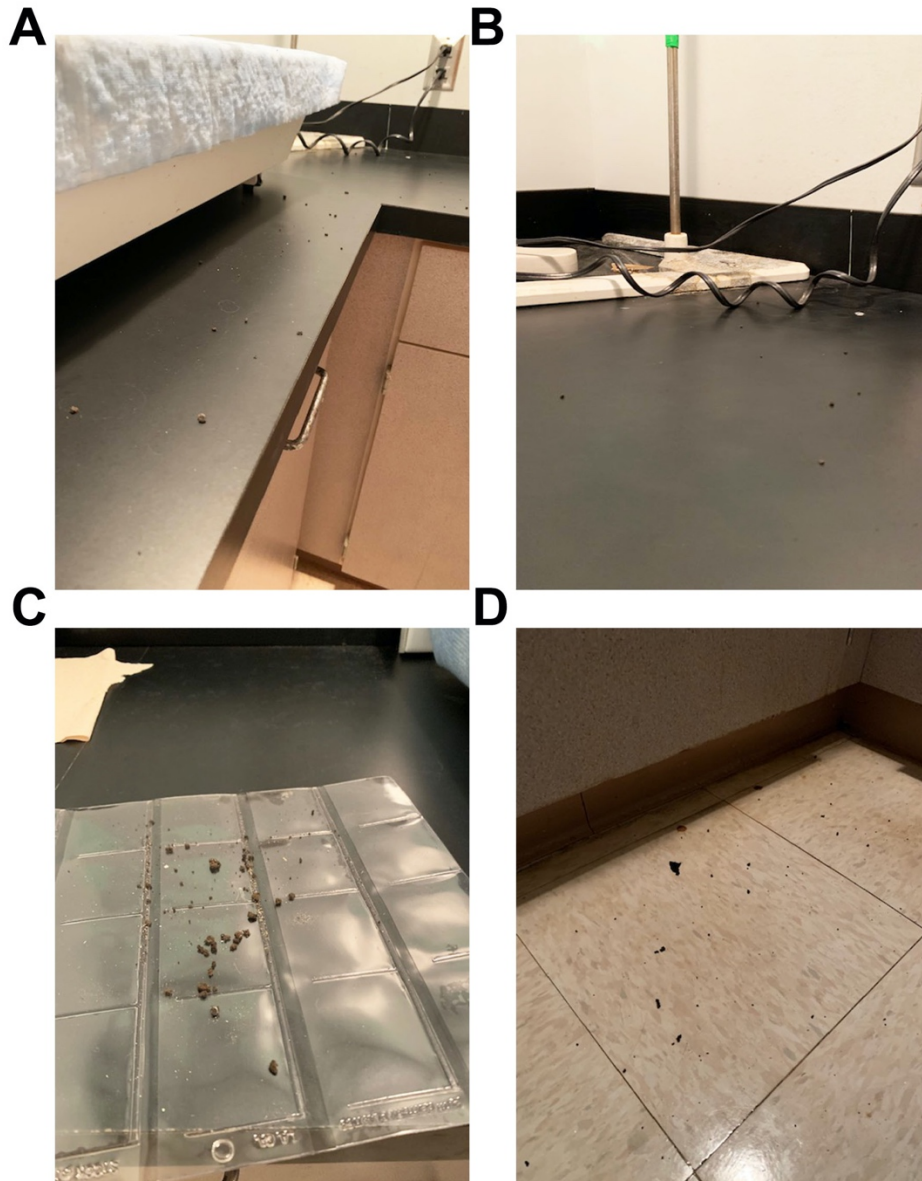
Figure 7. Dark room 422A after 4 months of cleaning. Pictures taken January 4, 2022, four months after the cleaning began show big chunks of black debris and fine black particles in benches (A and B). Particles from the benches were collected and are shown in C. Big black chunks also can be seen on the floor.

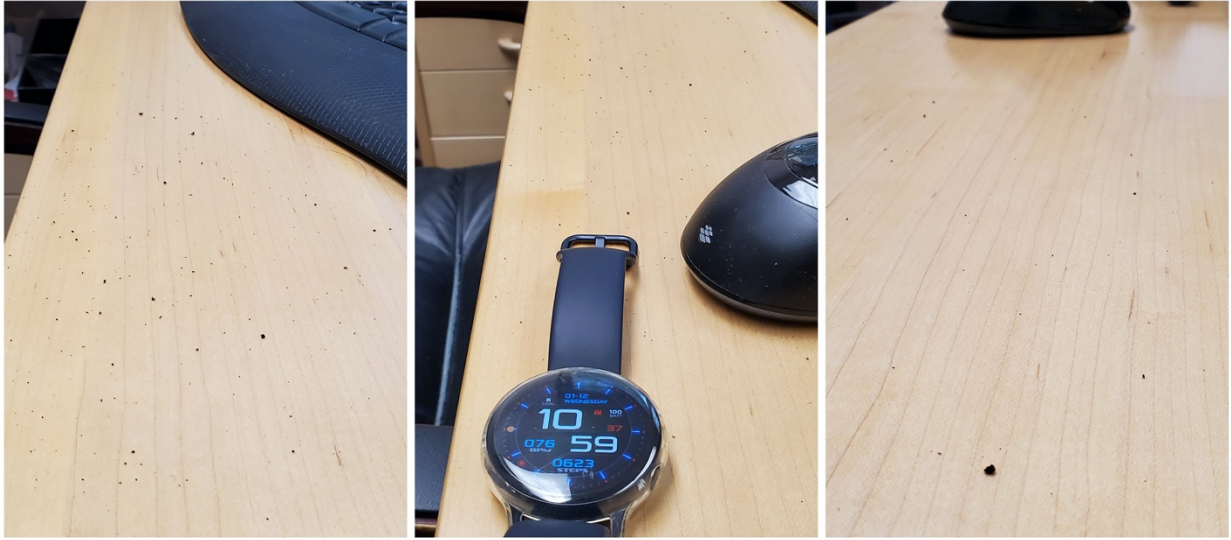
Figure 8. Dr. Kim's office in room 100B at Sandels building. Pictures taken January 11, 2022 show black particles of different sizes on top of Dr. Kim's desk.

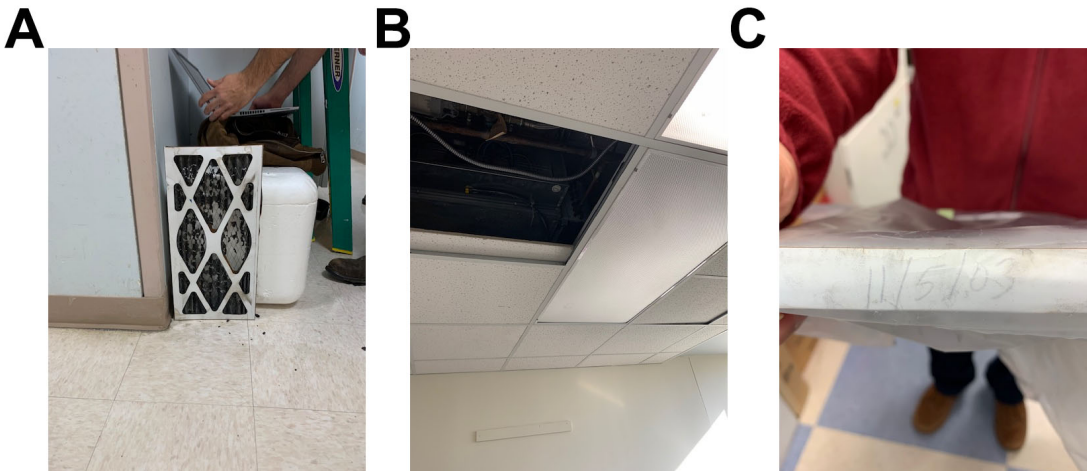
Figure 9. Old filter found in Dr. Salazar's lab room 442C. Pictures were taken January 18, 2022 and show a filter covered in black material (A) that was removed from the ceiling in room 442C (B). The filter hasn't been changed since November 5, 2003 (C).

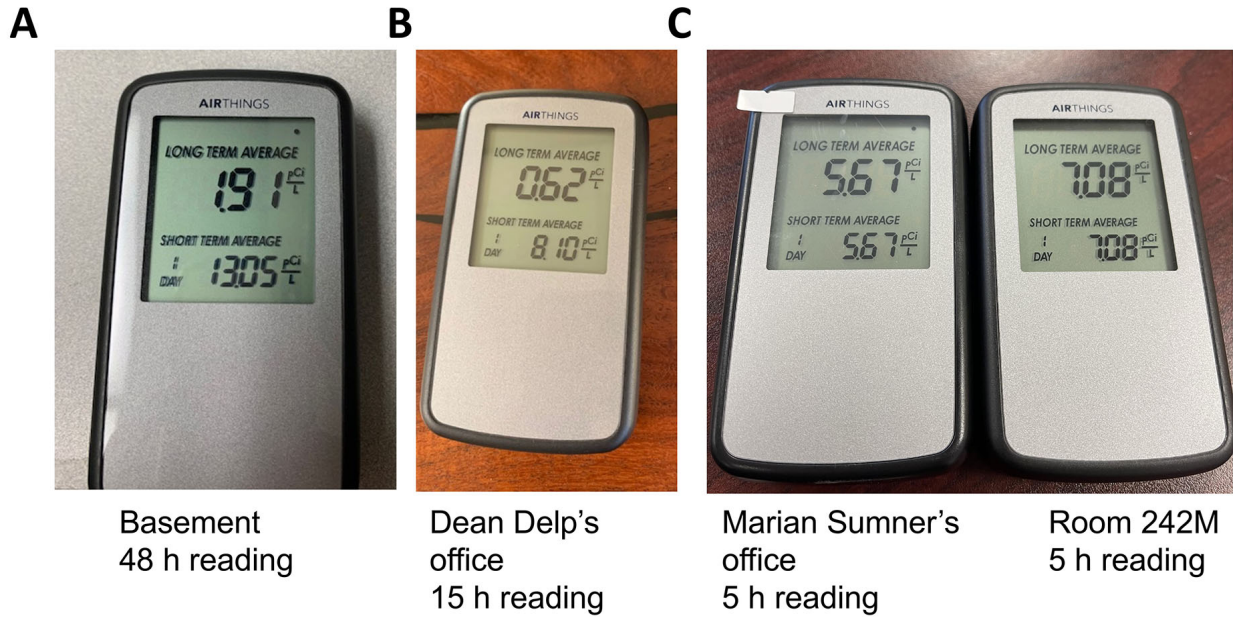
Figure 10. Elevated radon levels in ground floors in Sandels building. Pictures of radon meters placed in A) the basement (room B0007A), B) the Dean's office (room 242L), and C) Marian Sumner's office (room 242I) and room 242M. The number in the top reflects the long-term average. Current readings are reflected in the short-term average in the lower part of the screen. In C meters were reset to zero before measurements.

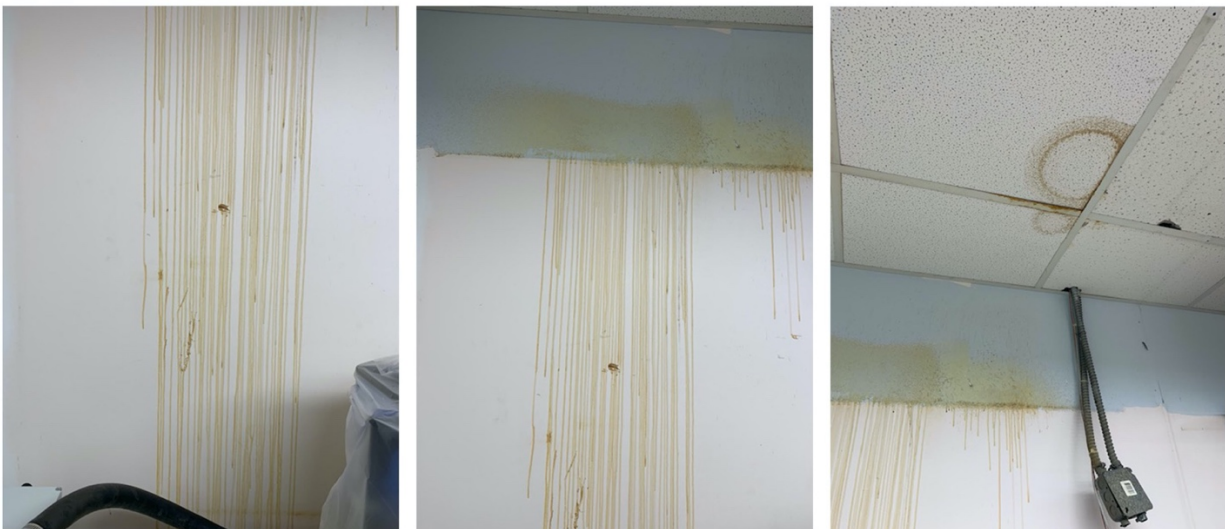
Figure 11. Room 442E Sandels building. Pictures show the condition of the wall where the chemical hood in room 442E was placed. Marks of a yellow liquid are a testimony of what was present inside of the hood.

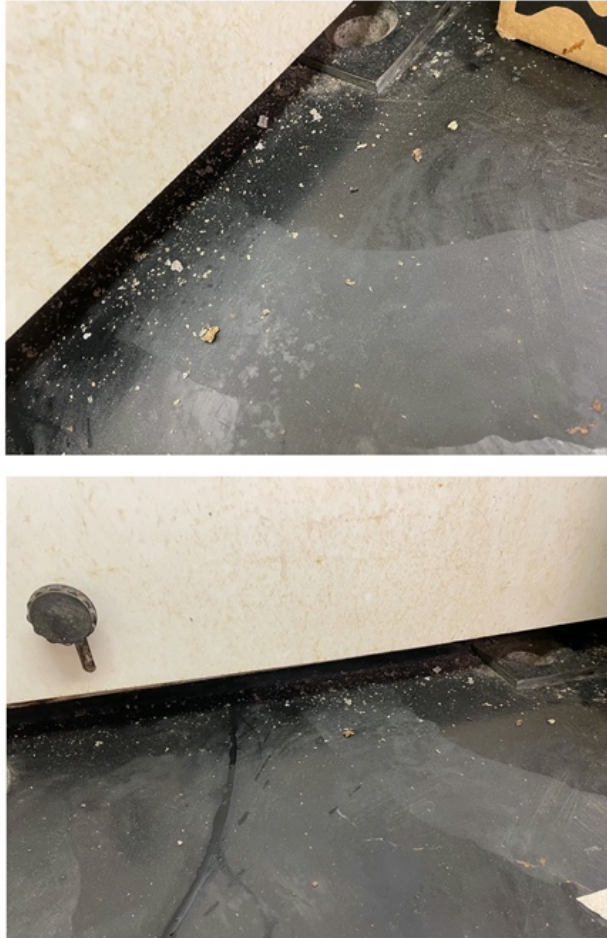
Figure 12. Chemical hood in Room 442G. Example of debris found in the chemical hood located in Room 442G, previously occupied by Dr. Sathe and currently assigned to Dr. Cui. Debris is constantly found inside the hood.
