## **Hazardous Working Conditions: Sandels Building, Florida State University**

January 21, 2022

On behalf of the Faculty and staff of the Department of Nutrition & Integrative Physiology with support from the staff of the Dean's Office, and the Faculty from the Department of Human Development and Family Science and the Jim Moran College of Entrepreneurship (former Department of Retail, Merchandising and Product Development).

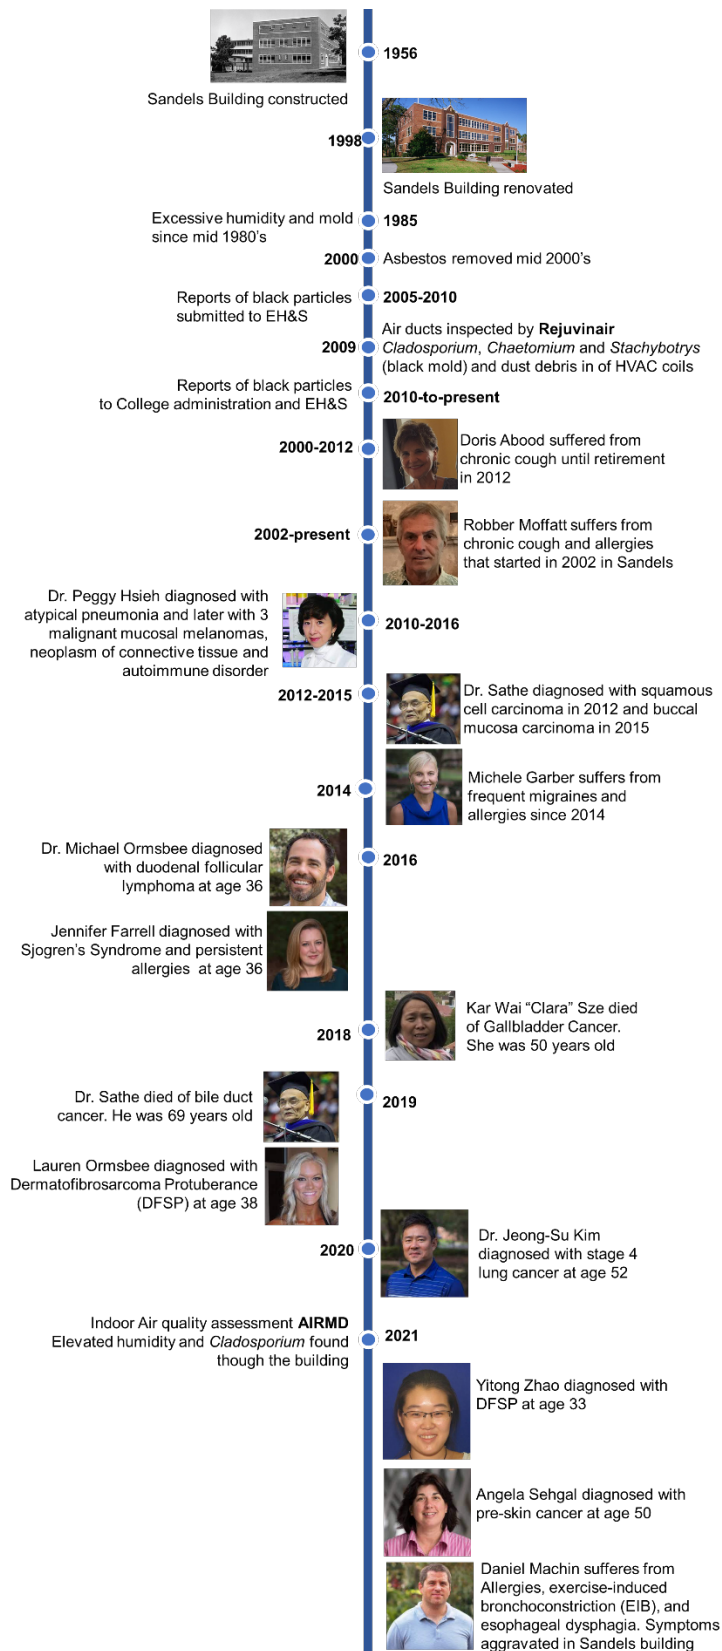
Several issues related to the building have been reported over the years by personnel working in the building since the mid-1980s (see **Figure 2**). One major issue was excessive humidity and constant mold mainly in the Dean's Suite, witnessed by Marian Sumner, an Administrative Specialist working in the Dean's Office since 1985. In the late 1980s, the building was sinking. This was mitigated by constantly pumping water into the foundation to stabilize the building. It is unclear whether the renovation of the building in 1998 was designed to fix the structural issues of the building. After the renovation, the issue with the humidity and mold continued until this date. In the mid-2000s, asbestos was removed, as reported by Ann Smith, an Administrative Assistant for the Department of Nutrition and Integrative Physiology (retired). However, there are no records of where the asbestos was found, nor was an exact date of removal known.

**Figure 2. Timeline of major disease cases and air quality assessments.** The air quality was assessed by Rejuvinair in 2009 and by AIRMD in 2021.
