CONSERVATION TREATMENT PROPOSAL FIVE FLAGS MURAL – STATE CAPITAL BUILDING

Artist:	Renée Faure
Title:	<i>Five Flags</i>
Date:	1978
Materials:	Watercolor on paper
Overall Dimensions:	114" x 288"

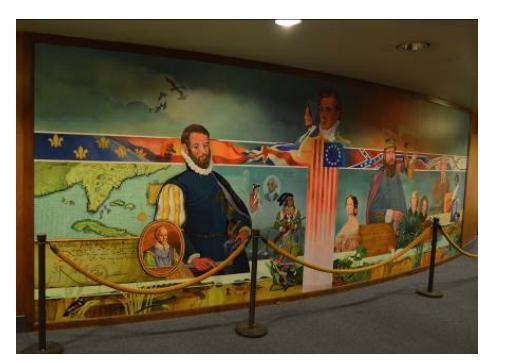
The artwork in question is a mural, painted on thick paper and adhered to wood veneer. It is attached to a curved wall from the floor to the ceiling with a wood frame around all edges. Fabrication appears to be two layers of paper of unknown thick composition glued in between layers and adhered further to the substrate, which is varnished wood paneling. The top sheet of paper is cut like puzzle pieces around the figures and background elements of the mural and glued

The artwork appears to be in good condition overall. In the central part of the mural some stains that may indicate that there was some liquid splashed before and needs attention. One of the figures of the artwork is visibly detached from the backing paper but can be intentionally made by the artist.

- 1. Documented treatment in detail with a written report and documentary photographs of the artwork before, during, and after treatment.
- 2. The surface will be lightly dusted and protected with a clear film, like Dartek, which will not be adhered to the surface.
- 3. The paper will be mechanically detached from the wood. We will use scalpels and sharp blades as the primary tools to aid in detachment.
- 4. After the piece is detached we will remove as much residual adhesive as possible to prevent damage to the surface.
- 5. Once the mural is detached we recommend rolling it onto a 16" Sonotube that is wrapped in acid free paper or Dartek, for safekeeping, using Dartek in between to keep it protected.
- 6. Provide a wrapper for exterior of mural.
- 7. If elements detach during treatment, bond them back using Japanese paper and wheat starch paste.
